# Douglas Park Drive Strategic Design Stage 1

27 November 2025

Wollondilly Shire Council

Stantec Australia Pty Ltd

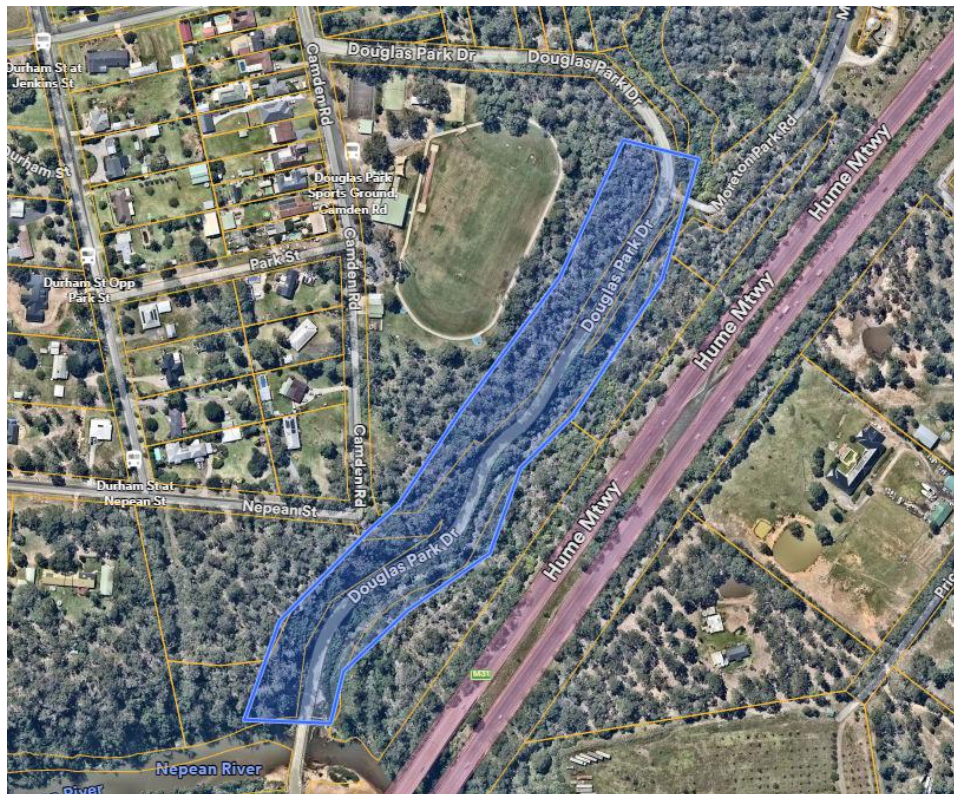
Figure 1-1– Project area

The project location is provided below in Figure 1-1 below with aerial imagery from (Nearmap, 2025).

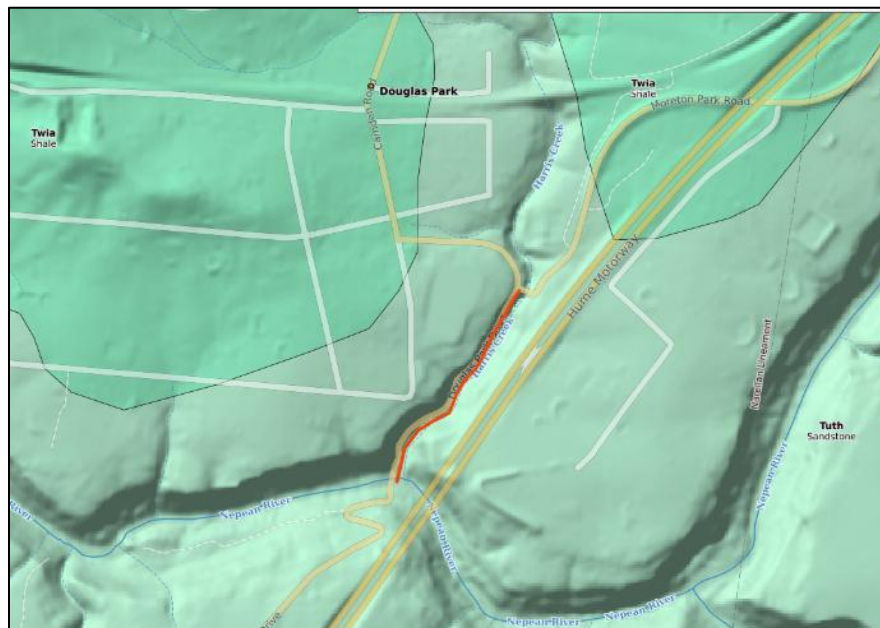
Figure 3-1– Regional geology

- **Twia:** Ashfield Shale, comprised of black to light grey shale and laminite.
- **Tuth:** Hawkesbury Sandstone medium to coarse grained quartz sandstone with minor shale and laminate lenses with series of massive, graded and cross-bedded sandstone beds.

The regional geology map of the investigation location is presented in Figure 3-1 below.

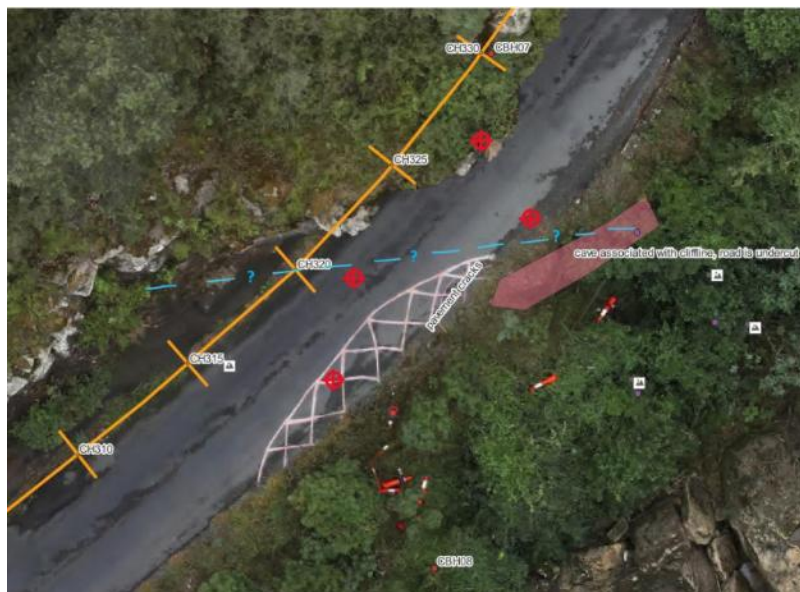
Figure 5-3– Previously interpreted buried cliffline

This slope domain contains SRA zones 5 and comprises and **ARL1**. Previous assessments in the area identified an abrupt change in the underlying ground conditions caused by a *'buried cliff line'*. Fill material comprised steeply sloping and, in some cases, undercut boulder stacks are in direct contact with vertical sandstone outcrop.

The upslope domain comprises steep sandstone cliffs up to 20m in height slope with large sandstone overhangs.

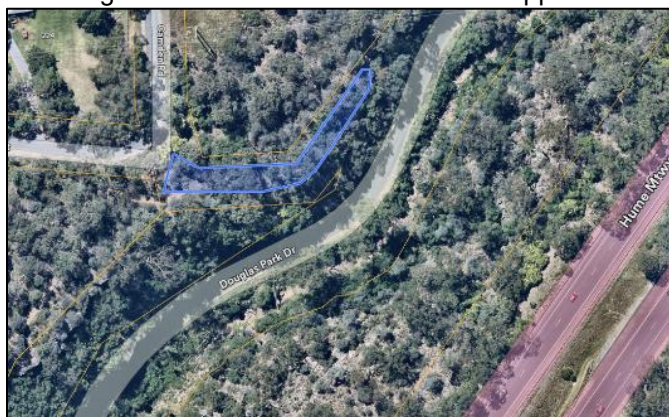
Figure 6-1– Existing track from intersection of Camden Road and Nepean Street.

An existing track and road corridor exists extending east from the intersection of Camden Road and Nepean Street in an easterly direction before swinging to a northerly direction. The following comments are provided for this option:

- Approximate chainage for the upslope track on Douglas Park Drive extends from CH140 to CH310.
- Track width ranges from 6 to 7m starting at the existing council street intersection and terminates approximately 6.5m above the adjacent road level of DPD at approximate chainage CH270.
- General down grade is 10H:1V generally consistent with DPD grading up. Continuing this down grade would intersect with DPD at approximate CH300.

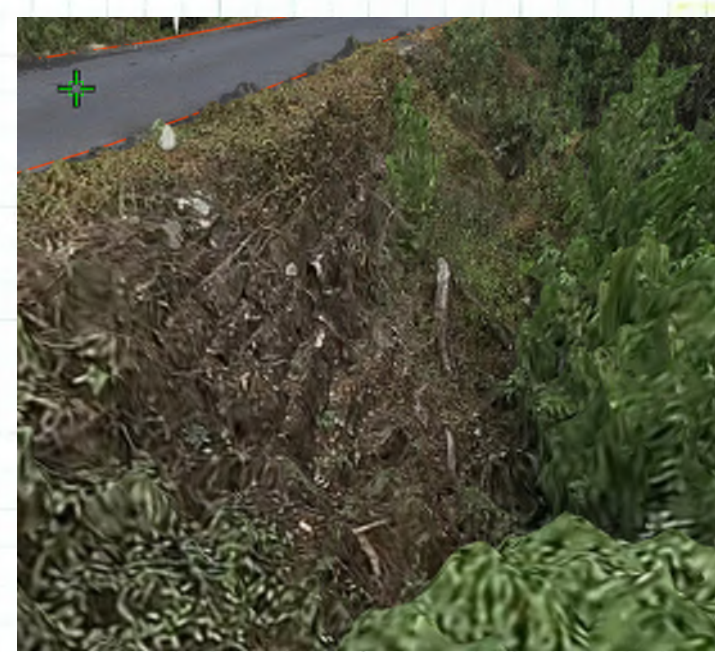
drone reality model of drystone wall

H1: drystone wall bulging failure. Live load distance from toe of wall falls in "H/2-H" range with minor signs of distress has a L4 likelihood of creating a small, up to 0.5m void

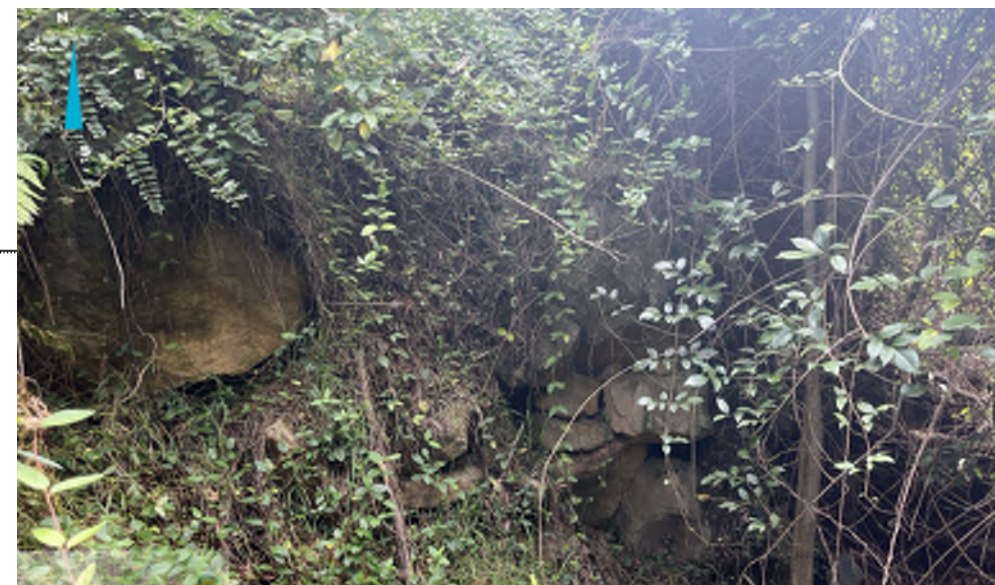
CROSS SECTION A-A'

H1: small rotational through fill profile, severe weather event to trigger a 100mm step in pavement on downslope lane, approx volume ~30m<sup>3</sup>.  
H2: large translational between fill and colluvium, unusually severe weather event to trigger a shallow void in downslope lane, approx volume ~200m<sup>3</sup>

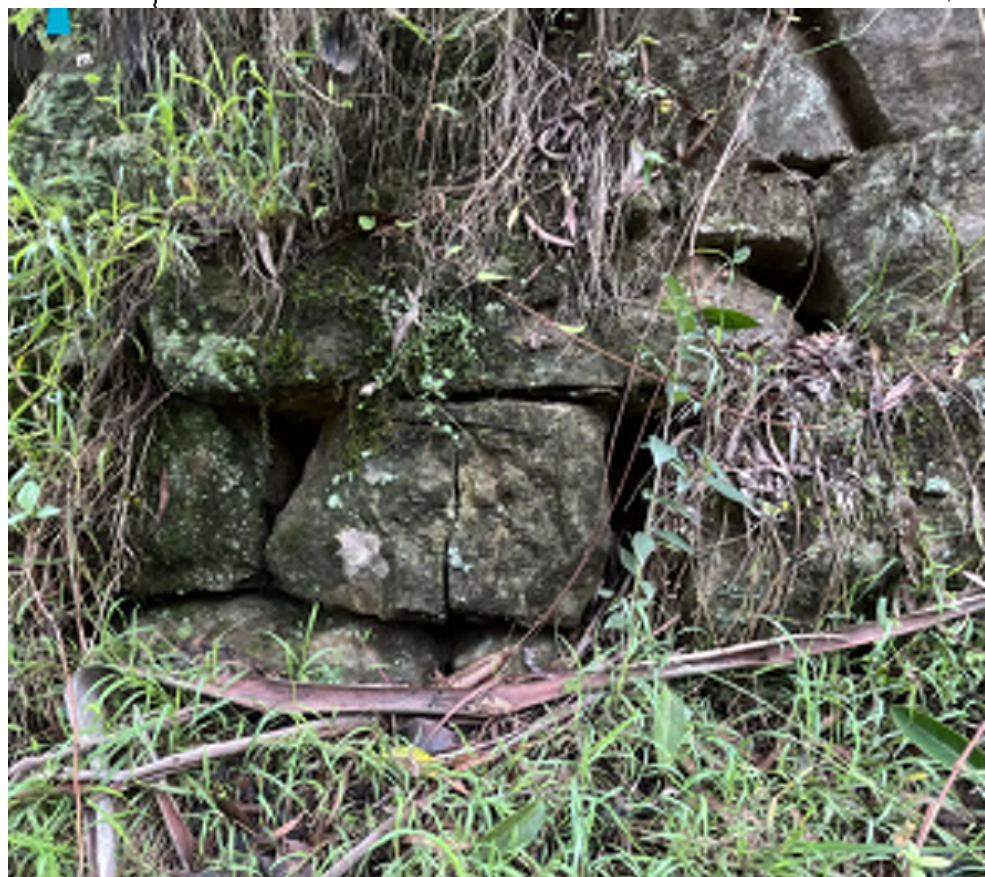
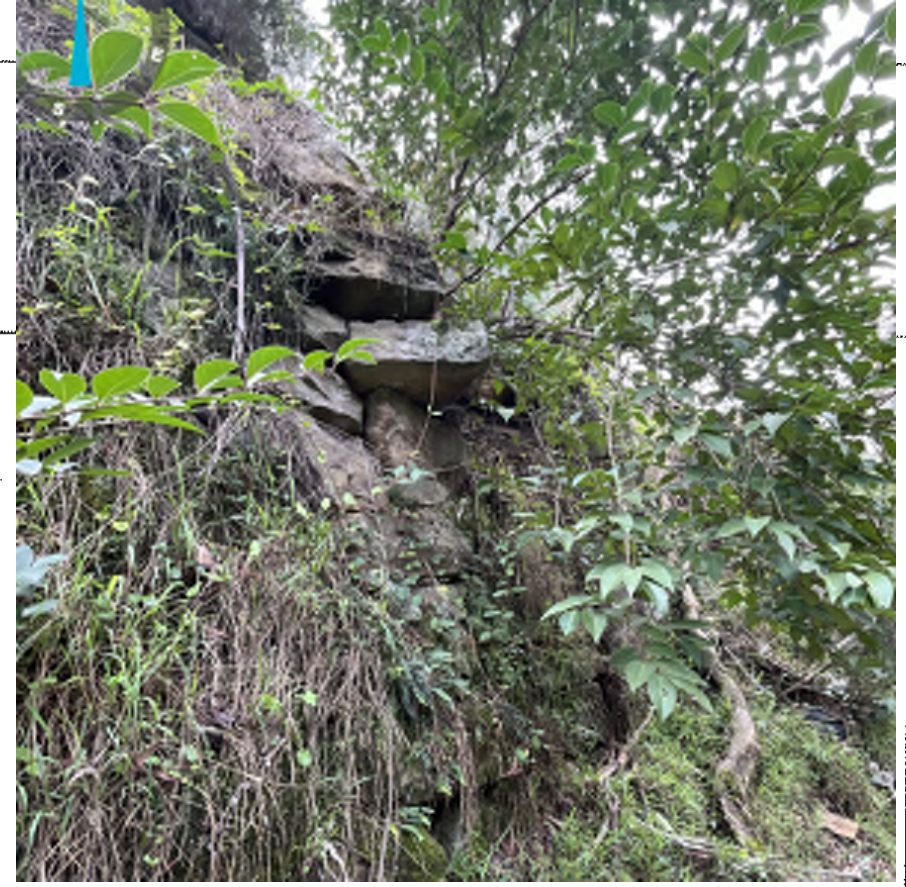
CROSS SECTION A-A'

H1: drystone wall bulging failure. Live load distance from toe of wall falls in "H/2-H" range while considered to be under significant distress has a L3 likely-hood of creating a small, up to 0.5m void.  
 H2: medium rotational failure through fill and colluvium/XW rock causing a 100mm step in road from an unusually severe weather event;  $P(d) = 0.001$ ,  $p(t) = 1.0$ ,  $L=L4$  approx volume = ~200m<sup>3</sup>

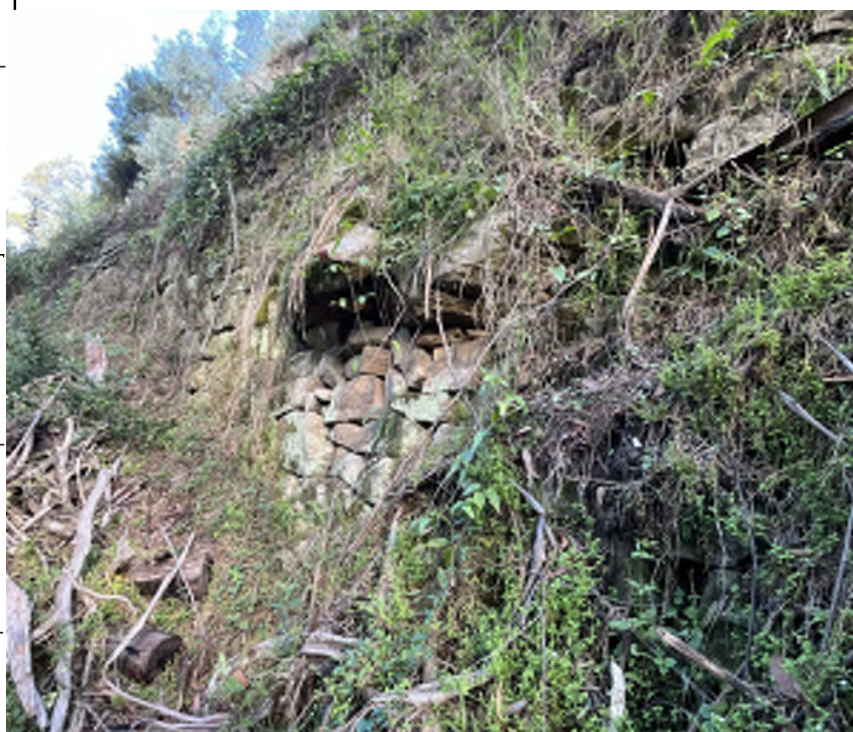
CROSS SECTION A-A'

H1: drystone wall in good condition, with rocky outcrop or large colluvial blocks incorporated in retaining wall construction. Live load distance from toe of wall falls in " $<H/2-H$ " range while considered to be under min distress has a L5 likelihood of creating a small, up to 0.5m void.

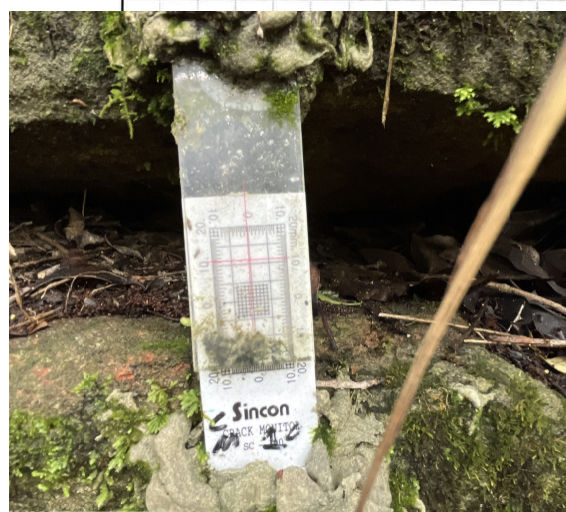
crack monitor on "new" wall

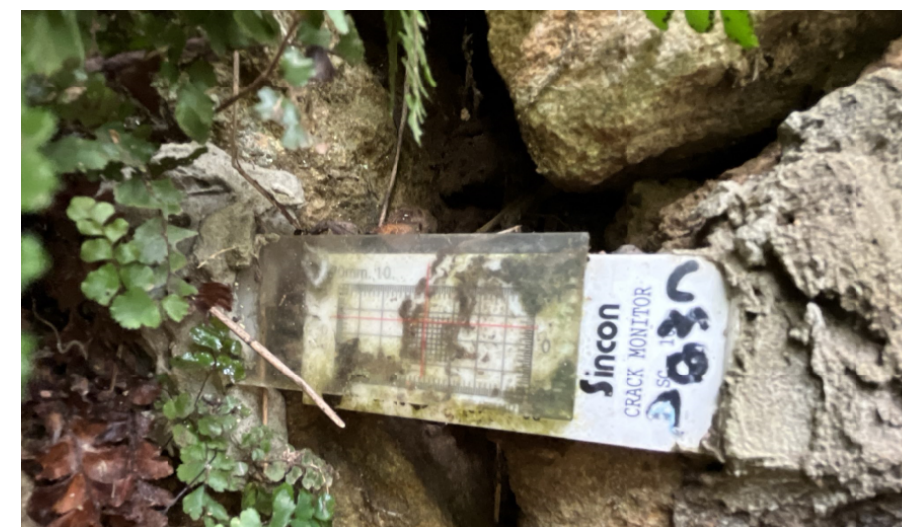
crack monitor between walls. Movement in two axis suggests sliding motion

H1: retaining wall bulge failure: blocks cracked, wall bulging and sliding. Live load distance from toe falls in "H/2" range while considered to be under significant distress and is apparently active gives a likelihood of L1

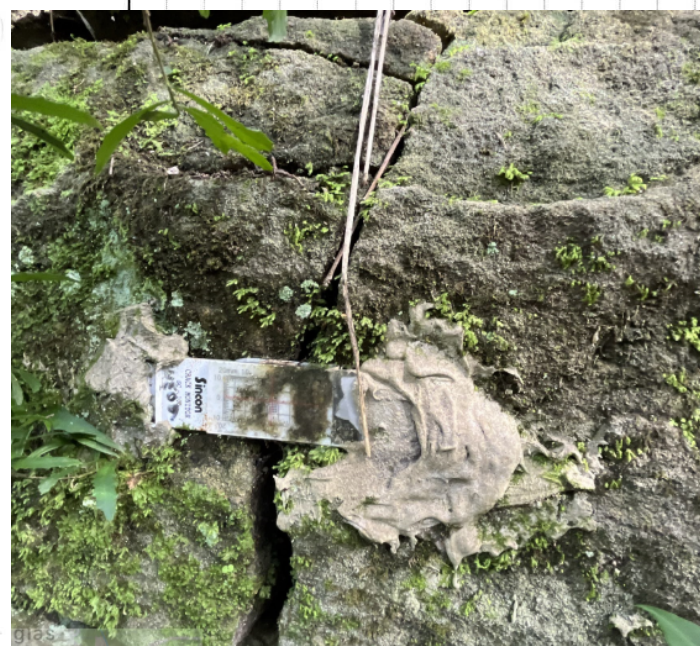
crack monitor on block on "new" wall

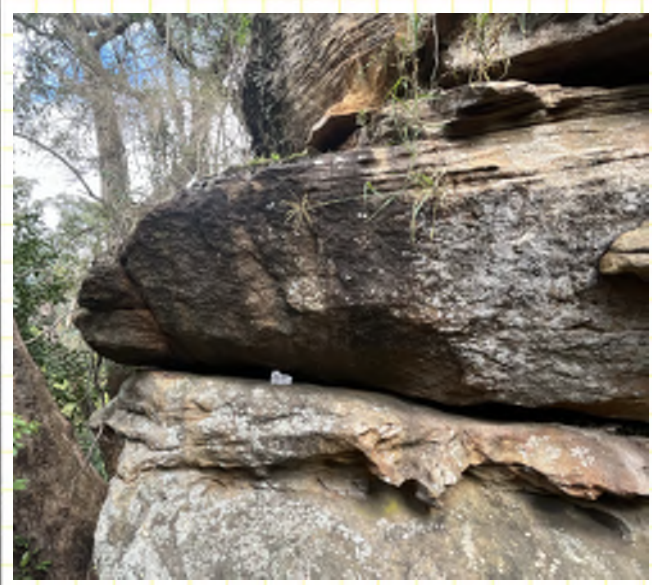
~100mm spacing between rock masses

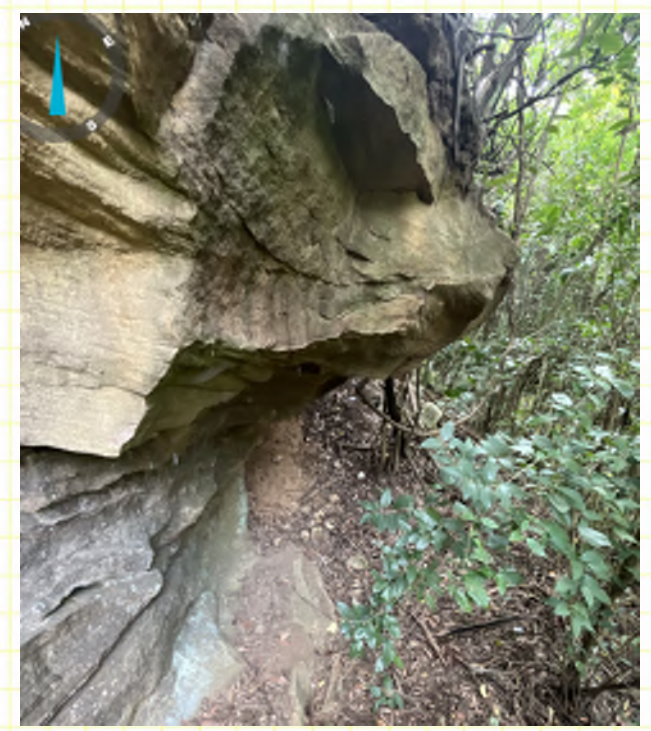
bottom cave

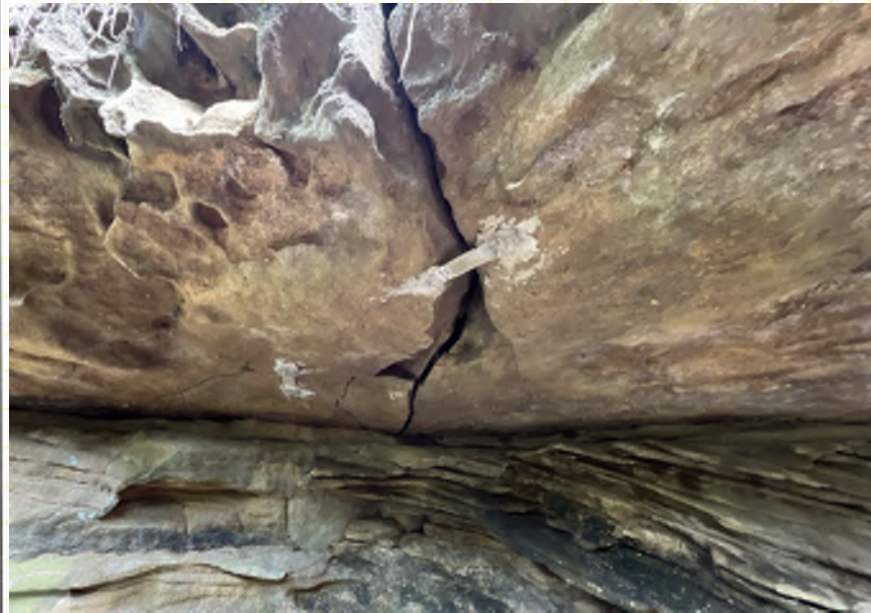
cracking in overhang

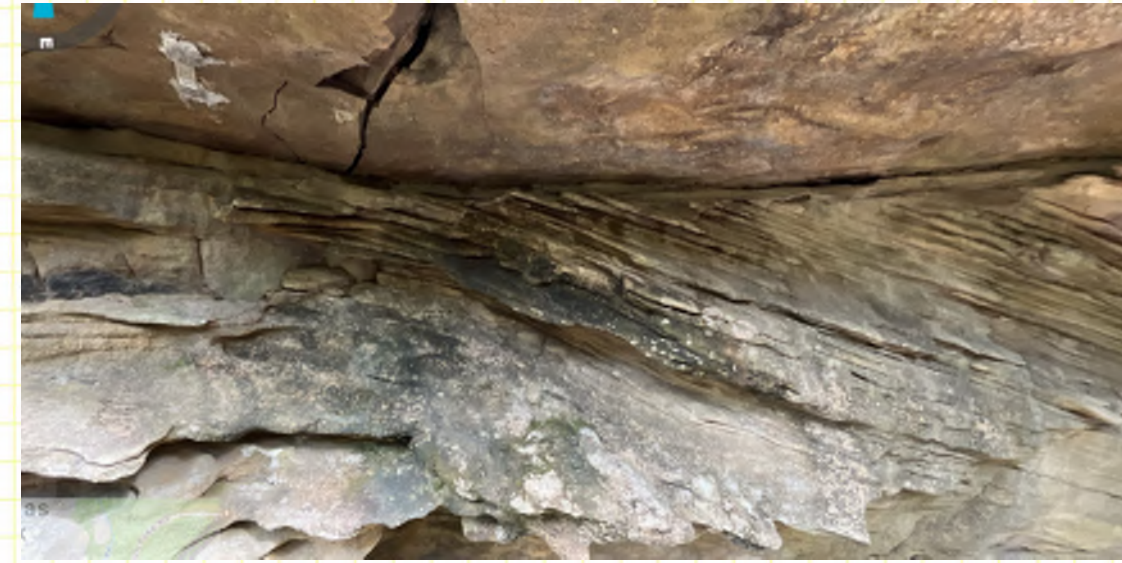
close bedding planes, with evidence of seepage

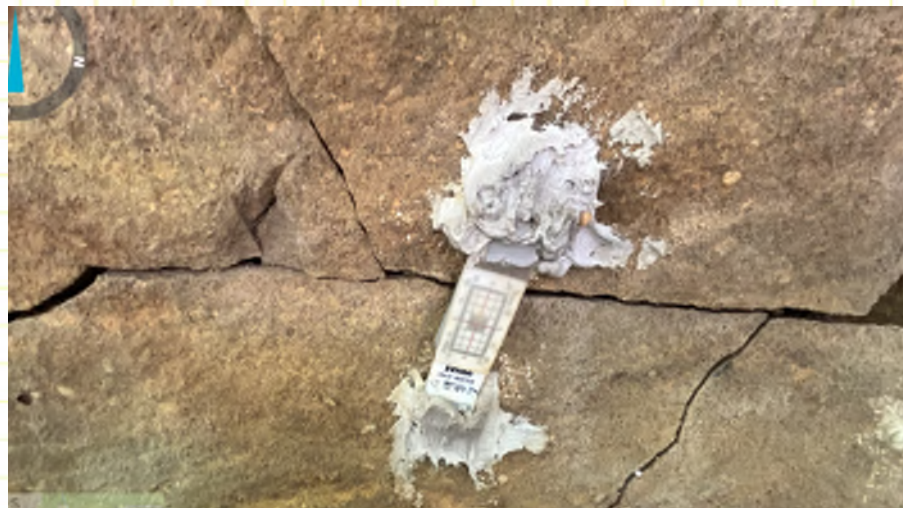
crack monitor showing no movement
